SAFETY DIRECTIVE 00001

Date Released:	July 8, 2020 (Revision 1 – Added servo tray identification) May 14, 2020 (Initial Release)
Date Effective:	July 8, 2020
Subject:	Pitch trim assembly inspection and modification
Affected Models:	RV-12, RV-12iS SLSA: Serial Numbers 12001 to 12086 ELSA: Any aircraft including an Empennage Kit shipped on or before 05/12/2020
Required Action:	Inspect the pitch trim motor shaft for straightness. Determine the model number of the installed trim motor. Determine the part number of the installed servo tray. Examine and ensure the F-1294B-1 lower tailcone fairing does not contact the trim servo linkage. If an ES MSTs-T3-7A-2 trim unit is installed, replace with the newer model unit, bushing, and F-1287A-1 Servo Tray once the life limit is reached, per the time of compliance below. Bag 2670 is also required. If an ES MSTs-B6-7T-165 is installed with F-1287A-1, add part BUSH-BS.188X.313X.222 per the time of compliance below. If an ES MSTs-B6-7T-165 is installed with F-1287A, replace F-1287A with F-1287A-1, and add part BUSH-BS.188X.313X.222 per the time of compliance below. Bag 2670 is also required.

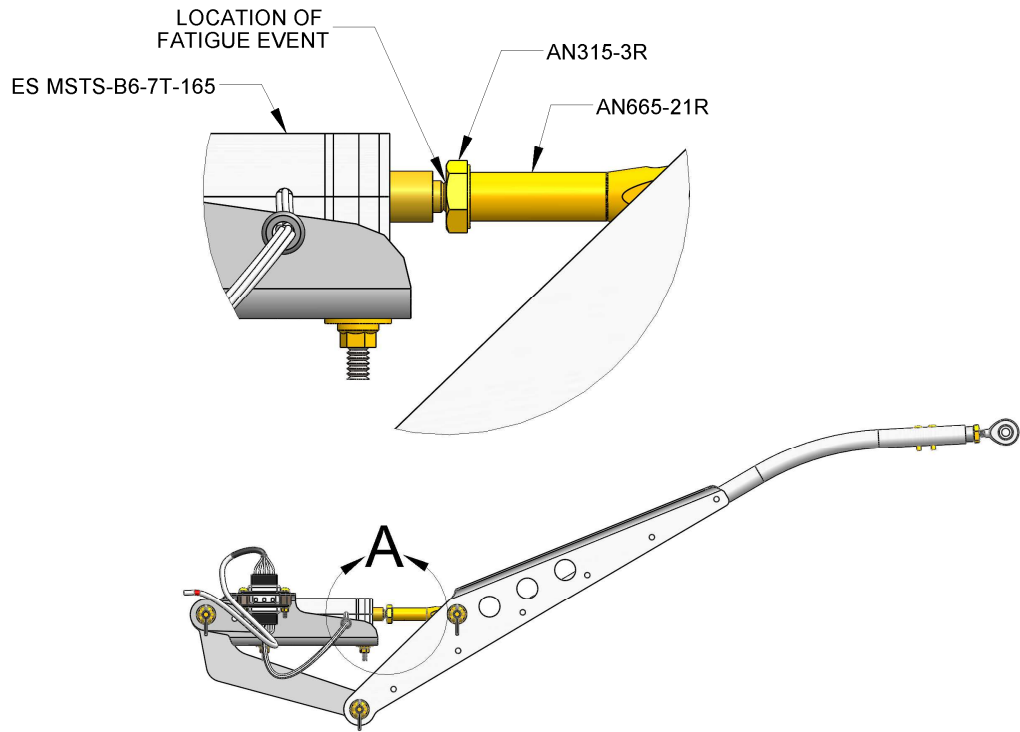
FIGURE 1: FATIGUE LOCATION

The described failure occurred in the threaded portion of the trim motor shaft, flush with the nut that tightens against the clevis. See Figure 1 below.

A test was then conducted in which the shaft was bent prior to starting the load cycle test. The bent shafts failed after a very high number of cycles at maximum load, in a manner similar to the failure of the trim motor in the field. As a result, Van's has determined that all trim motor shafts must be inspected for straightness before further flight. If the shaft is found to be bent, the trim motor unit must be replaced. A bent shaft should not be straightened and left in service. Analysis has shown that once a shaft is bent, small microcracks can occur in the base of the threads, which would eventually grow and result in a complete failure of the shaft.

Note that normal operational aircraft loading does not cause the shaft to bend. Damage to the shaft could potentially occur during assembly or inspection of the aircraft (for example, due to the application of a side load or if the trim motor was dropped) or if an individual pushed on the anti-servo tab with significant and substantial force (note that this area is marked "NO PUSH" via a placard located on the AST).

To resolve this potential risk, a bushing must be installed between the clevis and the shoulder on the ES MSTS-B6-7T-165 trim motor shaft. This bushing will transfer any bending load in the clevis safely to the shoulder of the shaft, which will prevent the threaded portion of the shaft from flexing and potentially fatiguing locally at the thread behind the nut. Van's strongly recommends installation of this bushing before or at the next condition inspection, and mandates that it be installed no later than 1,000 hours time in service.

Step 2: Inspect the threaded portion of the trim motor shaft. Determine if the shaft is bent. See Figure 1 below and KAI Section 11 for the RV-12 or KAI Section 11iS/U for the RV-12iS. If the shaft is bent, remove and replace the trim motor, add the bushing and replace F-1287A servo tray with the F-1287A-1. If the trim motor has accumulated 1000 hours time in service, replace the trim motor and tray with part number ES MSTS-B6-7T-165 and F-1287A-1, add the bushing, and ensure installation is compliant with the remaining steps in this document below.

Step 2: Inspect the threaded portion of the trim motor shaft. Determine if the shaft is bent. See Figure 1 below and KAI Section 11 for the RV-12 or KAI Section 11iS/U for the RV-12iS. If the shaft is bent, remove, and replace the trim motor.

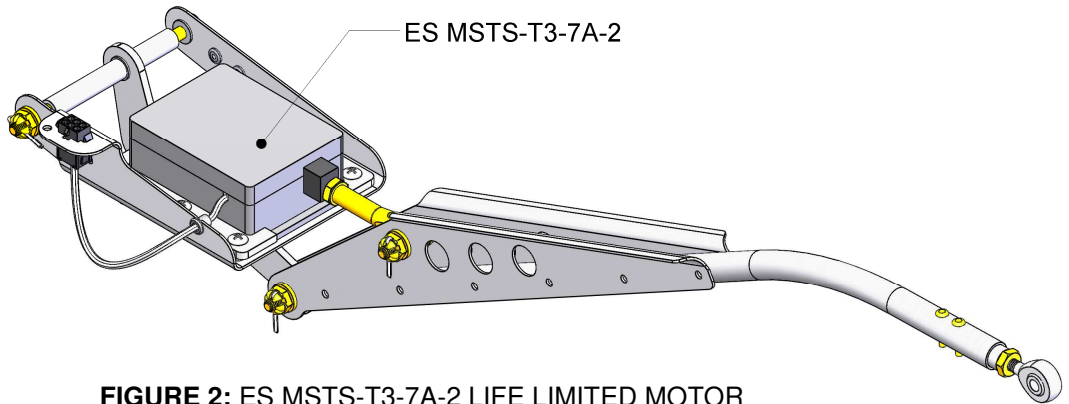
FIGURE 2: ES MSTs-T3-7A-2 LIFE LIMITED MOTOR

Older ES MSTS-T3-7A-2 trim motors incorporate a shaft without a shoulder. In addition, the entire shaft is threaded. As a result use of the new bushing mentioned above is not applicable. Through this Safety Directive, Van's is instituting a 1000-hour time-in-service life limit on the ES MSTS-T3-7A-2 trim motor design when installed in the RV-12/12iS. This limit is based on the results of the extensive fatigue testing that was conducted at Van's Aircraft. Any aircraft incorporating this older trim motor unit where the shaft is bent or the unit has reached 1000 hours accumulated flight time in service is directed to replace the unit with part number ES MSTS-B6-7T-165, F-1287A-1 Servo Tray, and bushing described in this document. The manufacturer of the trim motor unit, Ray Allen Company, has established a lower-cost return/exchange program for RV-12/12iS customers with a damaged or timed-out T3-7A trim unit. Cost to the owner is \$90 plus shipping. You may contact info@rayallencompany.com to arrange an exchange.

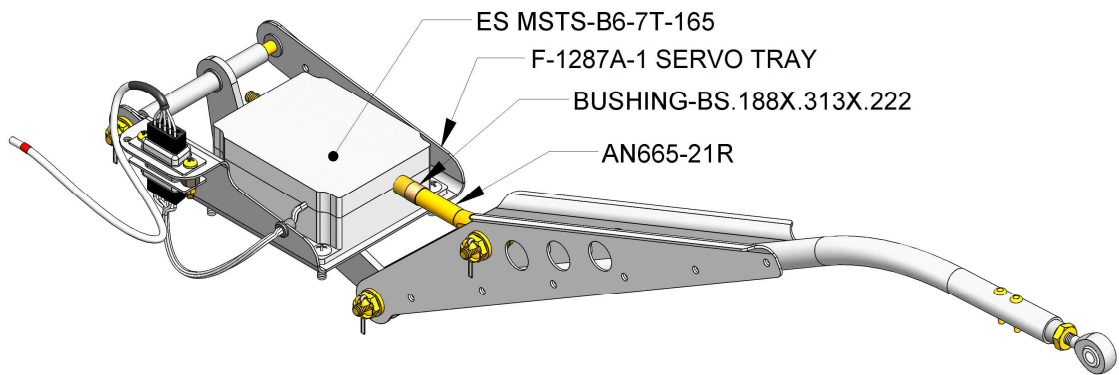
FIGURE 3: MODIFIED CONFIGURATION

If ES-MSTS-B6-7T-165 was installed in a F-1287A Servo Tray during a previous servo replacement, stabilator to anti-servo tab interference will result if the described bushing is installed. Therefore, F-1287A must be replaced by F-1287A-1 when the bushing is installed. To identify F-1287A-1 see Figure 3 below.

Step 6: Using the new KAI Section 11iS/U downloaded from the Van's Aircraft web site install the BUSH-BS.188X.313X.222 and clevis rod end onto the ES MST5-B6-7T-165 Trim Motor shaft. If the F-1287A Servo Tray was previously being used it must now be replaced with the F-1287A-1 Servo Tray. Re-attach the clevis rod end to the Trim/Servo Pushrod Assembly.
