SERVICE BULLETIN 16-05-23

Subject: WD-1230 Nose Fork cracks

Affected Models: All RV-12 aircraft using the WD-1230 Nose Fork

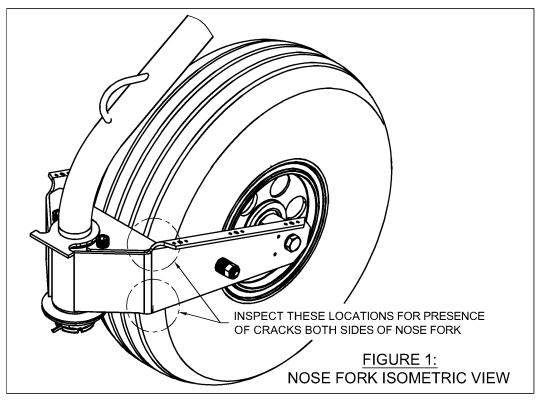
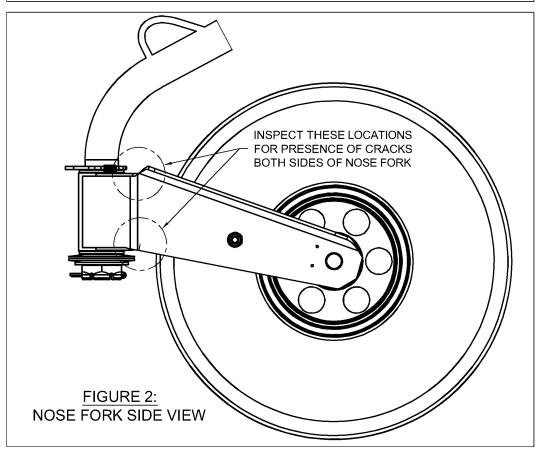
Several cracked WD-1230 Nose Forks have been reported on RV-12 aircraft in the field since the issuance of SB 10-12-14. In a handful of instances, the fork has failed.

<u>Step 2:</u> Visually inspect both sides of the WD-1230 Nose Fork for cracks in the locations shown in Figures 1 and 2.

<u>Step 4 (Cracking Found):</u> If cracks ARE discovered, immediately remove the nose fork from service and replace the nose fork using the kit(s) listed in the Materials Required section of this service bulletin. Skip to Step 7.

<u>Step 5:</u> At the next annual or 100-hour condition inspection following the release of this notice, replace the nose fork using the kit(s) listed in the Materials Required section of this service bulletin.
