**SERVICE BULLETIN 16-05-23**

**Subject:** WD-1230 Nose Fork cracks

**Affected Models:** RV-12, E-LSA and S-LSA

**Required Action:** Inspect WD-1230 Nose Fork for cracks

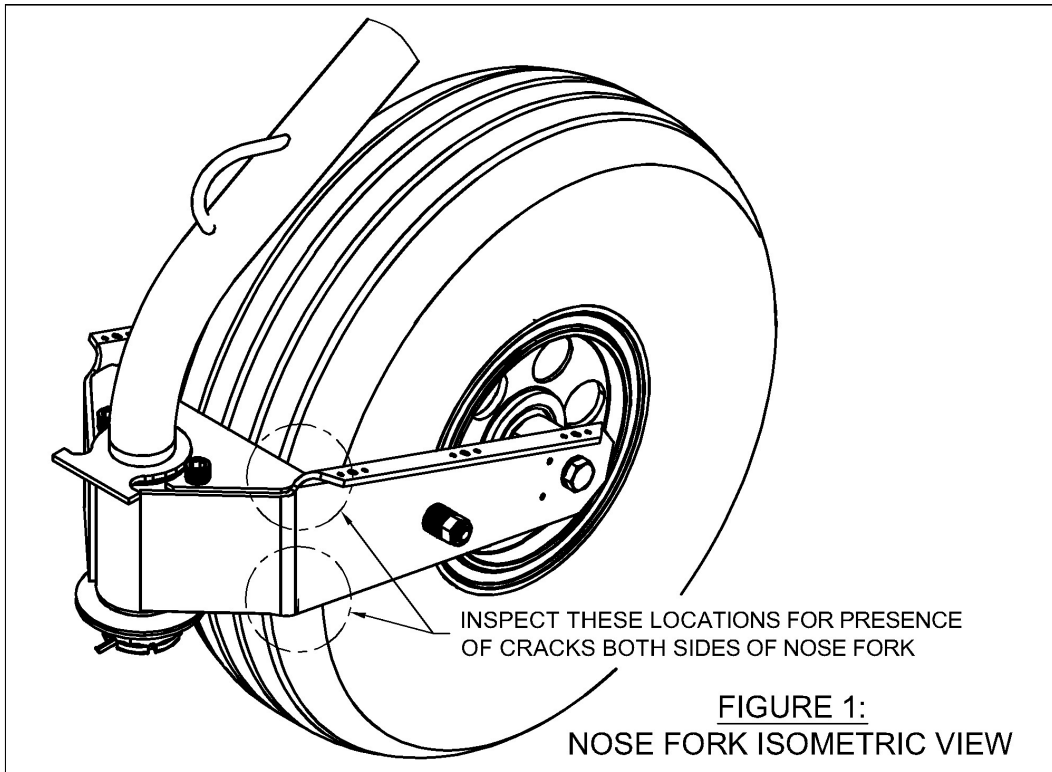
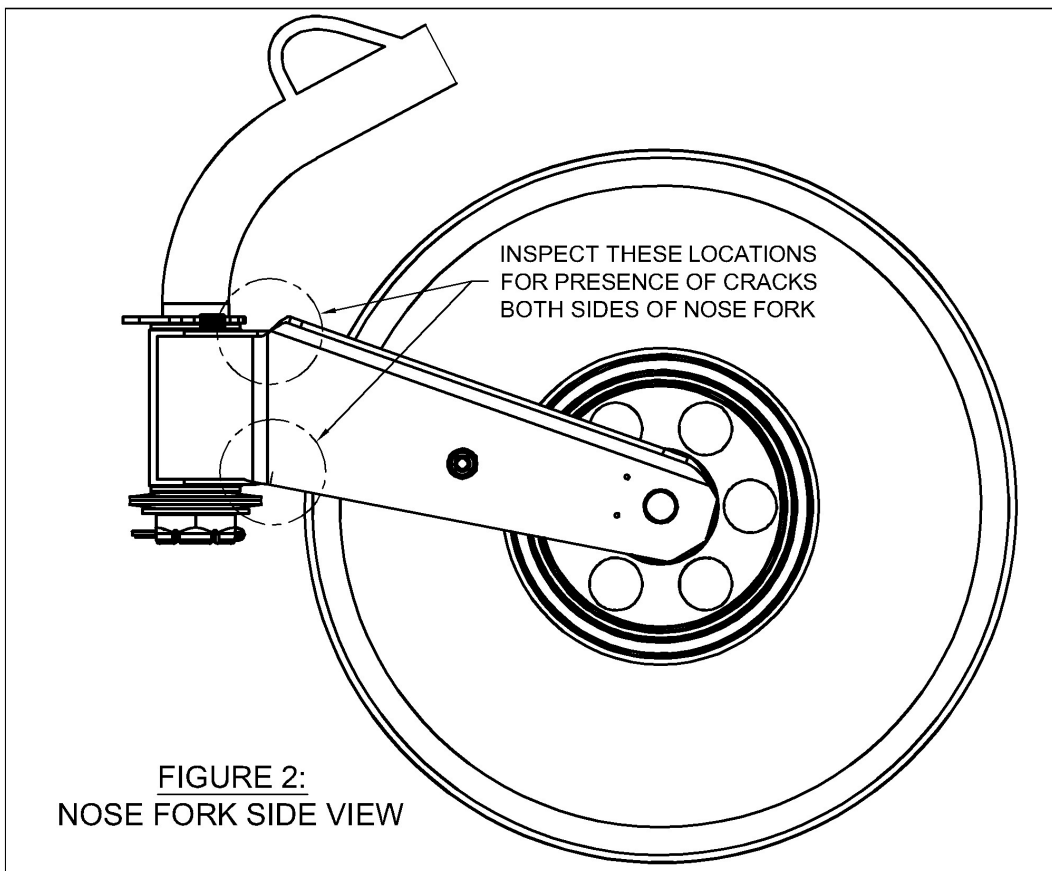
Visually inspect both sides of the WD-1230 Nose Fork for cracks in the locations shown in Figures 1 and 2.

If NO cracks are discovered, compliance with this Service Bulletin should be noted in the aircraft log and the nose fork may be returned to service.

If cracks ARE discovered, remove the nose fork from service and contact Van's Aircraft for replacement information.

Replacement Nose Forks are available from Van's Aircraft.
